January 5, 2016

Re: Lonesome Lake Dam (L-15) – Inspection Summary

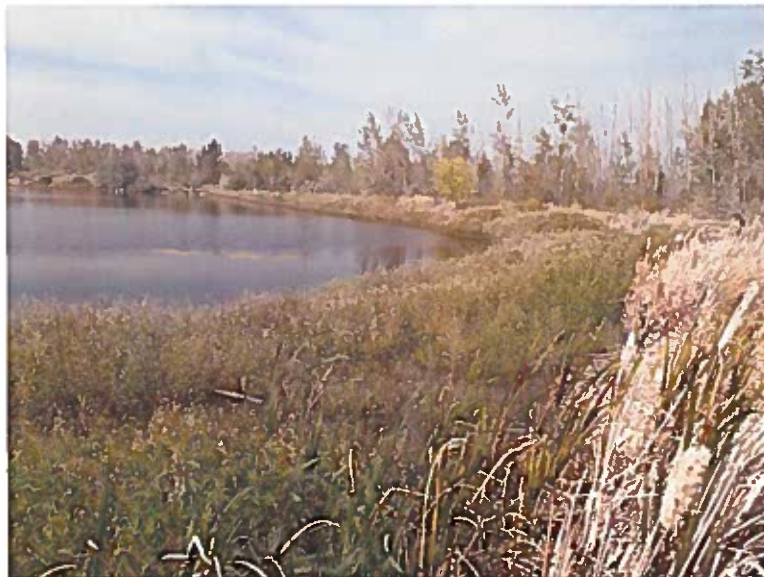
Dam upstream side, from right abutment. Note vegetation.

During the inspection, the reservoir was about 2 feet below the dam crest. Excessive vegetation along the shoreline hindered inspection of the dam's upstream side. Since the previous inspection, a screen was placed at the inlet to the spillway pipe, located on the upstream side of the dam near the right abutment. However, excessive vegetation and an accumulation of floating vegetation were observed on the screen. These conditions significantly restrict inflow to the spillway pipe. The spillway approach channel and inlet screen must be kept free of vegetative growth and debris.

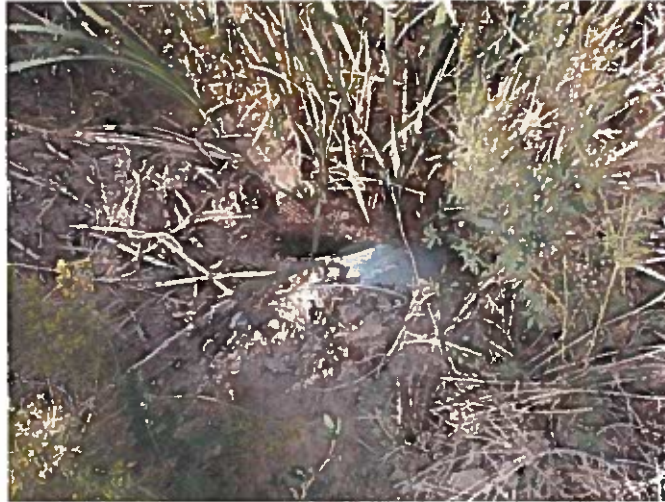
Summary: The dam is fair condition. Due to excessive vegetative growth and accumulated debris restricting flow at the pipe inlet, the spillway continues to be the main concern at the dam. To prevent overtopping, which could lead to dam failure, the spillway must be maintained to flow at full capacity. We have observed no evidence of valve operation over about the last five years. Additionally, the valve outlet still appears to be completely covered with soil and debris. The low level conduit must be functional to lower the reservoir, as needed, for maintenance or an emergency.

Spillway pipe inlet. Note screen, vegetation, and debris.

| Approach Channel | <input type="checkbox"/> Clear <input checked="" type="checkbox"/> Trees/brush <input checked="" type="checkbox"/> debris <input type="checkbox"/> erosion | | 2 |

1. Clear vegetation and debris from the spillway approach channel and pipe inlet screen, as needed to maintain full flow capacity. If this action is not sufficient to maintain full flow capacity, it may be necessary to construct an intake structure with a trash rack.
2. Clear soil and debris from the low level conduit outlet. It may be possible to do this by opening the valve. If the valve has not been operated recently, we recommend that you open it in the fall, when your need for water is lower, in case it requires repairs.
3. Remove vegetation from the dam upstream side and downstream toe.
4. Have an engineer submit final documentation so the water right process can move forward.

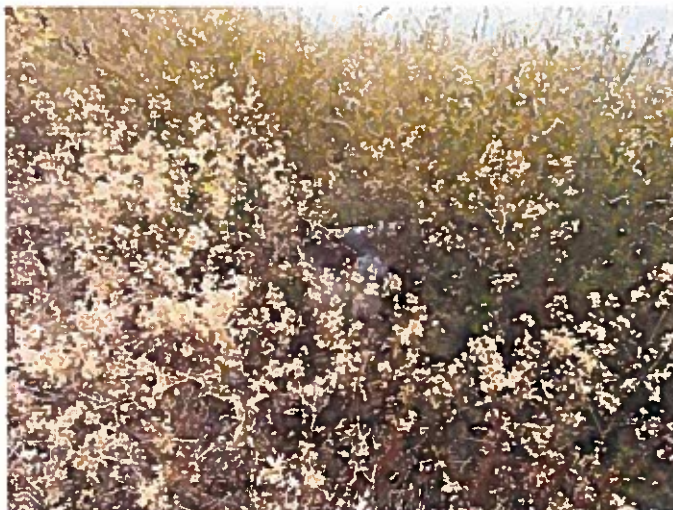
The top end of the operator stem for the low level outlet conduit is located on the upstream side of the dam. We could not inspect the low level conduit outlet, because it is buried under loose fill under dense vegetation. Based on the condition of operator stem and soil and rock covering the outlet, it appeared that the low level outlet valve had not been operated recently. The low level conduit and valve must be maintained so it is able to lower the reservoir, as needed, for maintenance or an emergency.

Operator stem for low level outlet valve.

| Control/Stem | <input type="checkbox"/> Operable <input type="checkbox"/> Damaged <input type="checkbox"/> Missing no wheel | | 4 |
| Comments: | valve stem did not appear to have been operated recently | | |

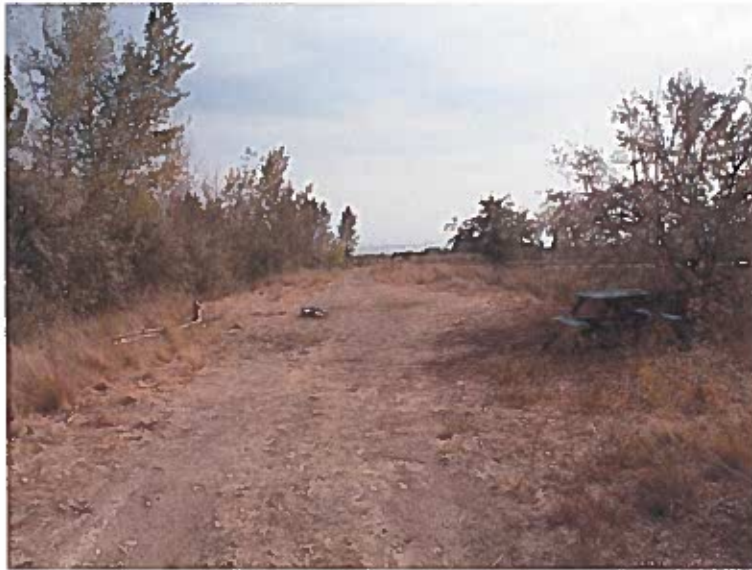
Dam crest viewed from left abutment.

No sign of settlement or cracking was observed on the dam crest. The dam crest is wide and clear of trees and brush to the shoulders. Past inspection reports state that vegetation was removed from the crest a few years ago. A few trees remain on the upstream shoulder. Excessive trees and brush were observed along the downstream toe.

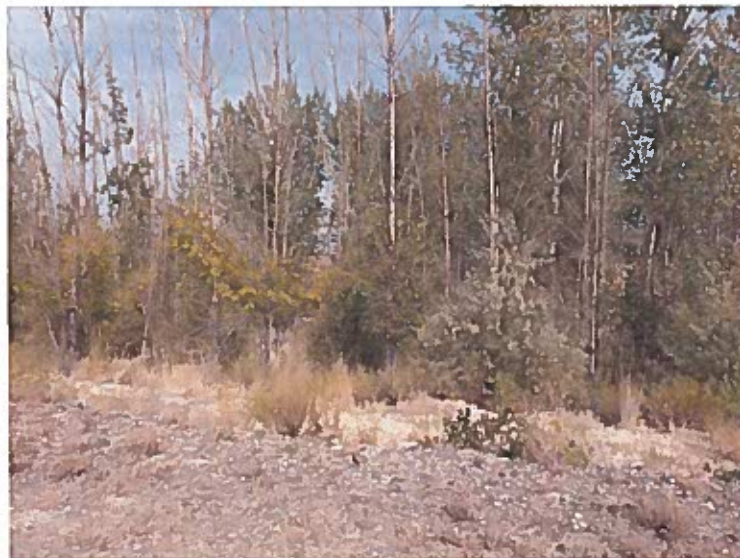
Dam downstream slope and toe, crest in foreground.

In addition to hindering inspection and access, trees and woody vegetation can have roots that penetrate deep into the dam. When the vegetation dies, roots decay and leave seepage paths in the dam, especially if there are burrowing animals. Also, taller trees are prone to blowing over, which can also compromise the dam integrity.
